NOLTR 61-174

TECHNICAL EVALUATION OF THE ZUNI
ROCKET BASE FUZE MK 191 MOD 1

4 DECEMBER 1961

UNITED STATES NAVAL ORDNANCE LABORATORY, WHITE OAK, MARYLAND

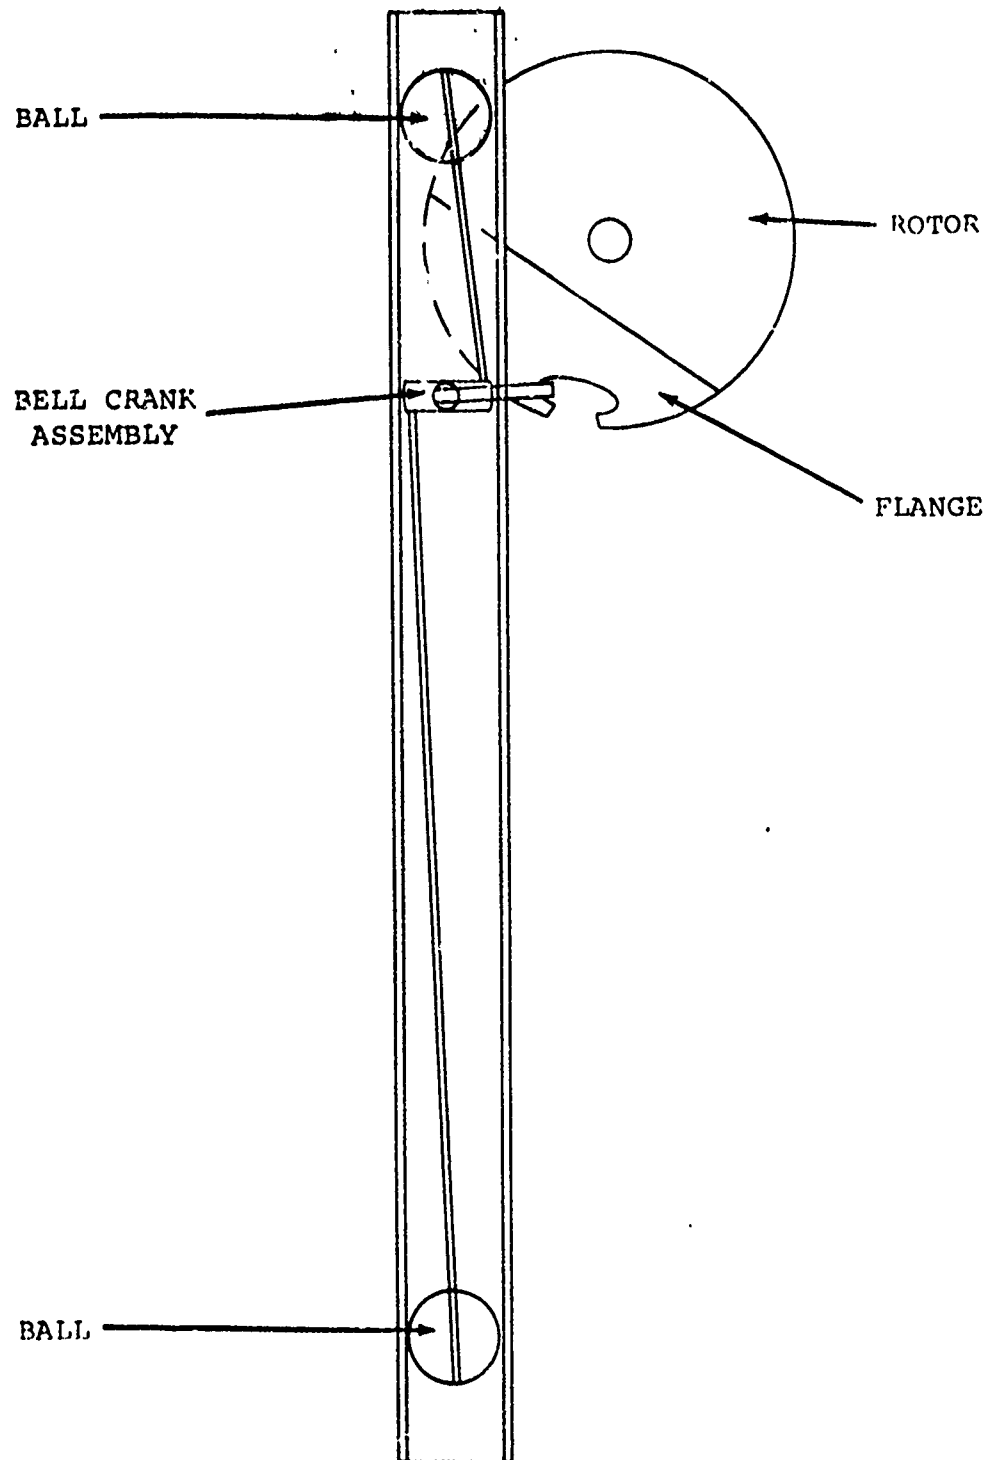
FIG. 3 SAFETY MECHANISM ASSEMBLY

5. The safety mechanism assembly (Figure 3) consists of two balls linked to a bell crank assembly. This assembly is held in position inside a tube attached to the bottom of the forward arming mechanism. The bell crank arm is engaged in a notch in the rotor flange of the forward mechanism. The two balls are positioned at two specific distances from the center of gravity of the rocket head. Since the centrifugal acceleration of a mass is directly proportional to its distance from the center of rotation, the acceleration forces exerted on the two balls are unequal when the head is caused to tumble. In the accidental release situation, where the head separates from the rocket motor and tumbles about its center of gravity, the forces exerted on the two balls and the bell crank arm act to prevent the arm from disengaging from the rotor flange notch, and the rotor is locked in the safe position. Under linear rocket acceleration, the forces exerted on the two balls and the bell crank arm allow the arm to disengage from the rotor flange notch as the rotor moves to the armed position.

16. Modified forty foot drop tests were conducted to check the effectiveness of the safety mechanism assemblies. These tests were conducted so that the nose of the inert Head Mk 24 struck the edge of an I beam after dropping 25 feet and caused the head to tumble during the final 15 feet of drop. The fuzes were inert except for primers and detonators. Ten rounds were dropped. The first missed the I beam and struck the steel plate on the ground in the horizontal position. The remaining nine rounds all struck the I beam and tumbled during the remaining 15 feet of drop. None of the mechanisms, forward or rear, armed. However, several of the primers fired and several of the safety mechanism assemblies were found unlinked from the forward mechanisms. The fired primers were probably due to poor solder connections of the circuit breaker leads at the primer housing terminals. This condition would in effect remove the circuit breaker and allow the primer to be fired upon a suitable impact. The condition of the arm of the safety mechanism assembly moving from the forward mechanism could be explained by at least three possible occurrences. The mechanism hooks were distorted in several cases, indicating that those impacts were severe enough to force the arms out of linkage. It is also possible that after the arm had restrained the mechanism from arming, and tumbling had ceased, that as the setback weight was returning the rotor to the safe position a slight impact caused the arm to separate from the mechanism. A third possibility was presented by an investigation of a group of forward mechanism assemblies, which revealed that in about 10 percent of the

samples the fit of the safety mechanism assembly arm in the rotor slot was such that, if the rotor slack is taken up in the armed direction, the arm could easily be moved in and out of the rotor slot. Such a mechanism could become unlinked by a light impact. These tests did not check the effectiveness of the safety mechanism assembly and additional tests were made.

17. Ten repeat rounds were dropped with reworked fuzes. All struck the I beam and tumbled before striking the steel plate on the ground. None of the mechanisms, forward or rear, armed. None of the safety mechanism assemblies became unlinked from the forward mechanisms.
